A geological assessment of the landslides in the Ironbridge Gorge, Shropshire

Prepared for Wardell Armstrong LLP
by the British Geological Survey

Commissioned Report CR/08/157N

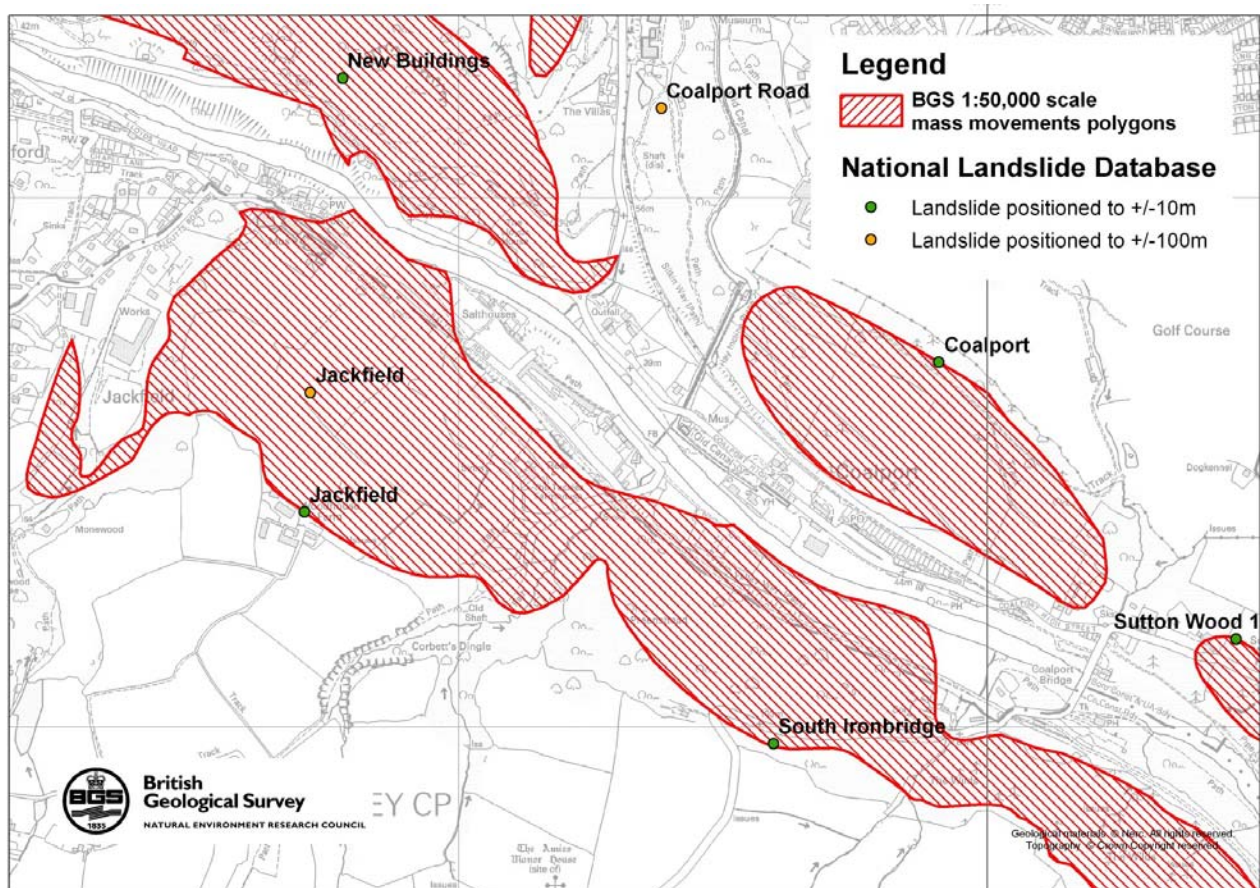
Figure 11 Extract from National Landslide Database showing Jackfield, New Buildings, Coalport, Coalport Road and South Ironbridge Landslides. DiGMapGB-50 mass movement polygons are also included in this map.

Hamblin and Coppack (1995) resurveyed the site (NLDID 4335/1) in the 1980s and stated that this slip was clearly not caused primarily by the dip of the strata, which is to the south-east, or by underground workings. It was a translational shear with its base wholly within the weathered zone (at a depth of 5.2 m) and parallel to the slope of the hill. A sheet of material 183 m long

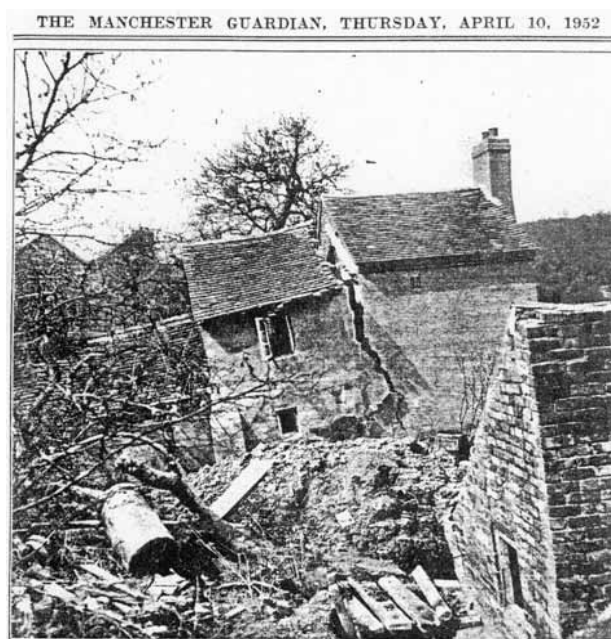
moved through 18m at its centre but only 9 m at the river bank, causing bulging and cracking of the surface, with damage to houses, railway and mains services. By April 1953, the length and width of the slide had increased to 213 m and 200 m; the horizontal movement was 24 m at the centre and 14 m at the river bank. The slide had extended uphill by means of minor rotational slips, and the River Severn had been narrowed from 38 m to 24 m.

Figure 12 Pear Tree Cottage, damaged by the 1952 Jackfield landslide and demolished the following year (Manchester Guardian, 10th April 1952).

This landslide has since been remediated and Carson and Fisher (1991) noted that: "*the approach adopted was to weight the toe of the slide with tile waste and seal the surface cracks with clay won locally by regrading the slope. The regrading was to allow easy drainage and remove humps and hollows which might otherwise trap surface water and trigger local slips. The remedial works were satisfactory for thirty years albeit with higher maintenance costs until a similar slip occurred in 1981/2 closing a section of road which slipped into the river. A similar approach to remedial works was adopted as for the 1951 slip but with additional drainage and the road diverted along the disused Severn Railway track. The road construction however, consists of hinged wooden boards on a granular base. Movement has continued and the road has to be ballasted every few years. A rock toe has been constructed both to add weight and reduce the loss of material to the river in conjunction with counterfort drains. The remedial works have not stabilised the slide completely but appears to have slowed down the rate of movement*".

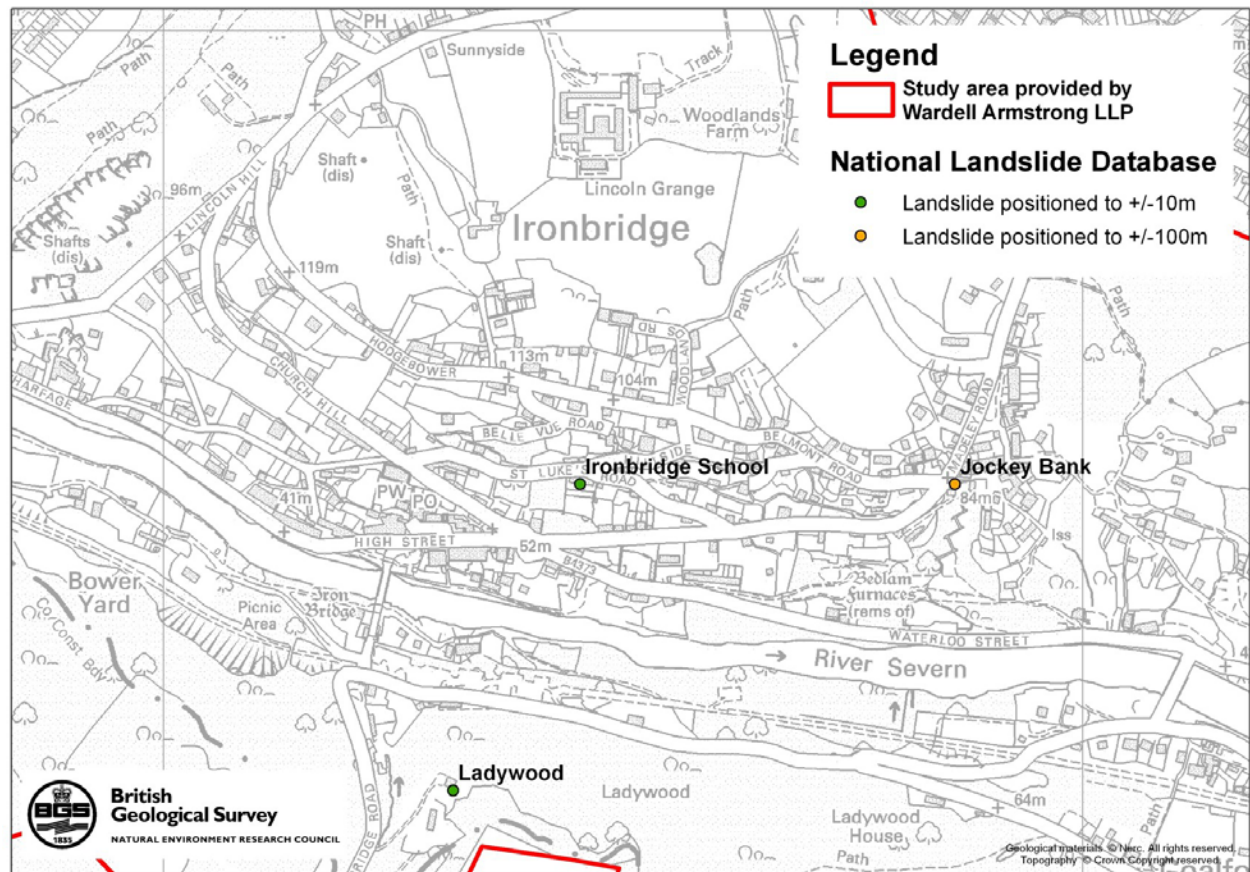
The Ironbridge School landslide (**NLDID 4336/1**; Figure 13) is described in detail by Culshaw (1972a), Hamblin and Coppack (1995) and Denness (1970)³ as a rotational and translational landslide and was first reported in 1969, when the land between the school and the road below suffered considerable movement. The pavement had frequently been ruptured and soil cleared off the road. The old playground has sunk by about 1.2 m and walls running downhill either side of the school were severely fractured.

The area immediately below the school was the most active part of a larger unstable area. The fill material forming the flat playground behind the school became waterlogged. This loaded the Coal Measures on the steep slope below, and caused a rotational landslide which extended down to the Ironbridge-Madeley road. This was probably exacerbated by the extent of old workings in the Coal Measures and the lack of mains drainage in Ironbridge.

Figure 13 Extract from National Landslide Database Ironbridge School, Jockey Bank and Ladywood Landslides. There are no DiGMapGB-50 polygons in this area.

This landslide (NLDID 4365/1; Figure 13) occurred in 1988/89 and has been documented as a translational landslide where part of a private access road to a house was damaged; it was 24 m wide, 34 m long, 3.5 m deep and with a volume of 2856 m³ (Giles, 2008).

This landslide has been remediated (Culshaw, pers comm.). It is notable that the landslide is located close to the axis of a syncline that channels groundwater into it from the Big Flint Rock, just above the school (Culshaw, 1973a). This is further discussed in Section 4.

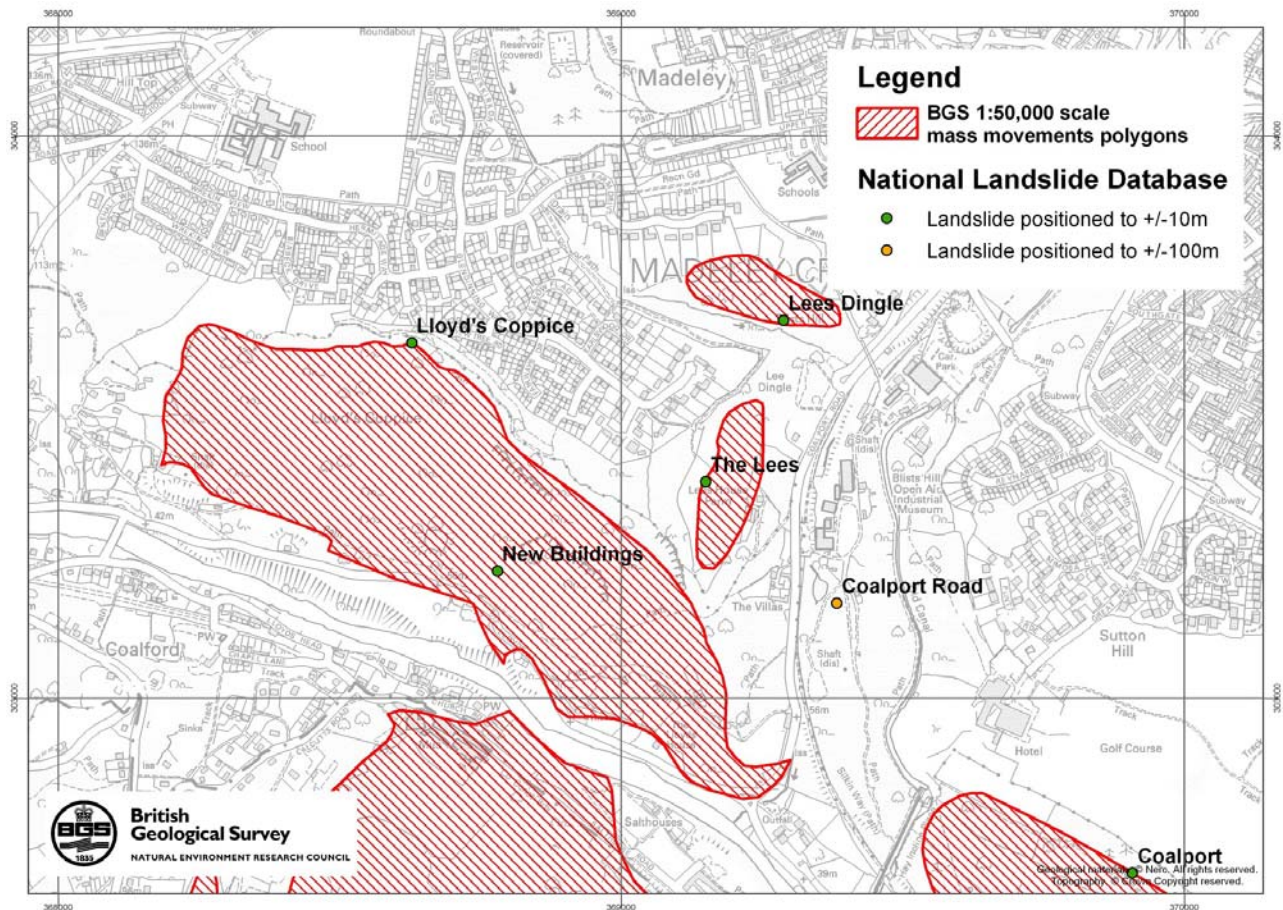
A large area of the Halesowen Formation is actively moving as a series of rotational slips and surface slides. Crags of Thick Rock sandstone have moved down from their outcrop near the top of the hill, bringing with them the overlying thick till. The Halesowen Formation is particularly susceptible to degradation in this area as it includes more silty strata and less sandstone than elsewhere. Although slipping is thus most active lower on the slopes, it does not appear to extend down to river level.

Figure 14 Extract from National Landslide Database including Lloyd's Coppice, New Buildings, The Lees, Lees Dingle and Coalport Road. DiGMapGB-50 mass movement polygons are also included in this map.

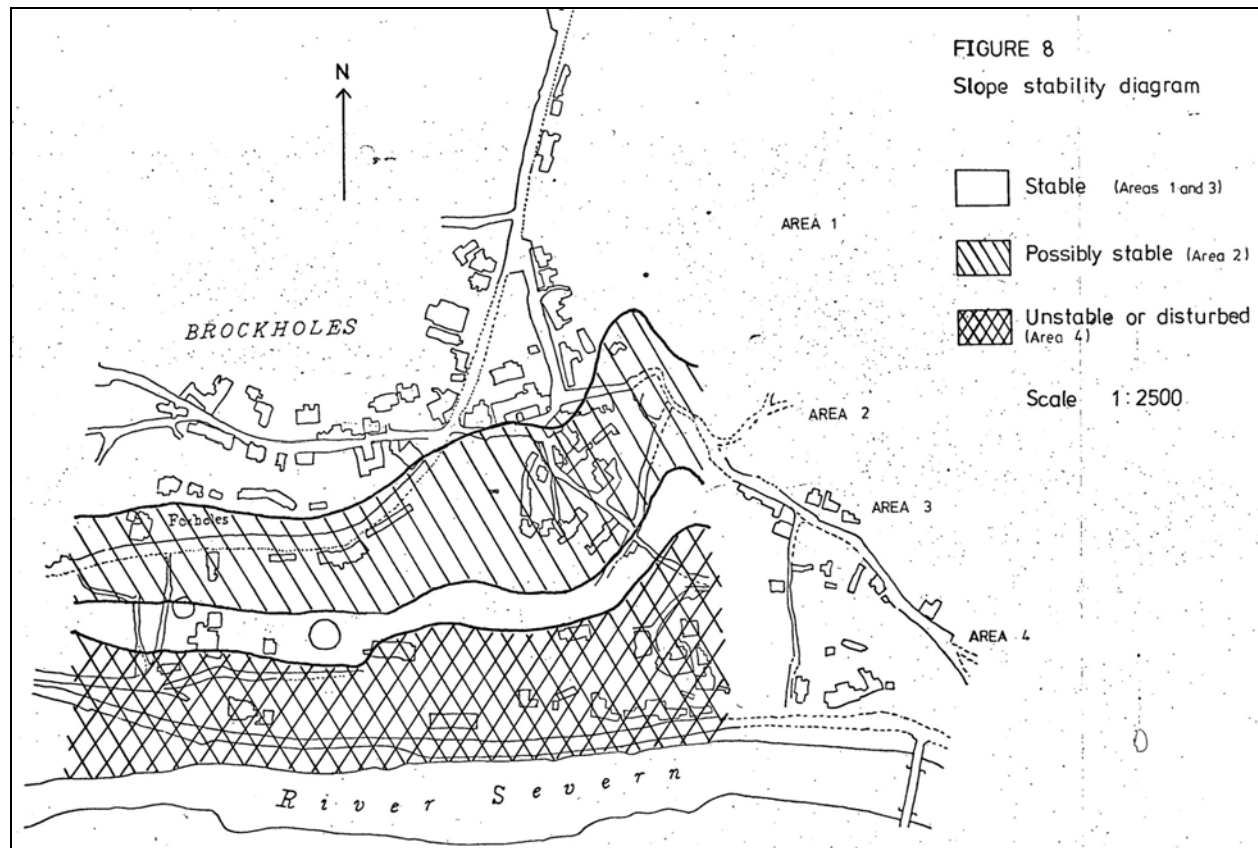
The buildings of Jockey Bank, while being in bad condition structurally (some unoccupied or derelict) did not appear to have suffered any damage near the time of survey due to landslide movement. The cause of slipping in this area follows the pattern of Lloyd's Coppice. The top of the hill around Lodge Farm is composed of sandstone which acts as a primary reservoir. This releases water down slope towards Jockey Bank which reduces soil strength which has caused the slipping.

Figure 15 Slope Stability Diagram of Jockey Holes landslide (taken from Culshaw, 1972b).

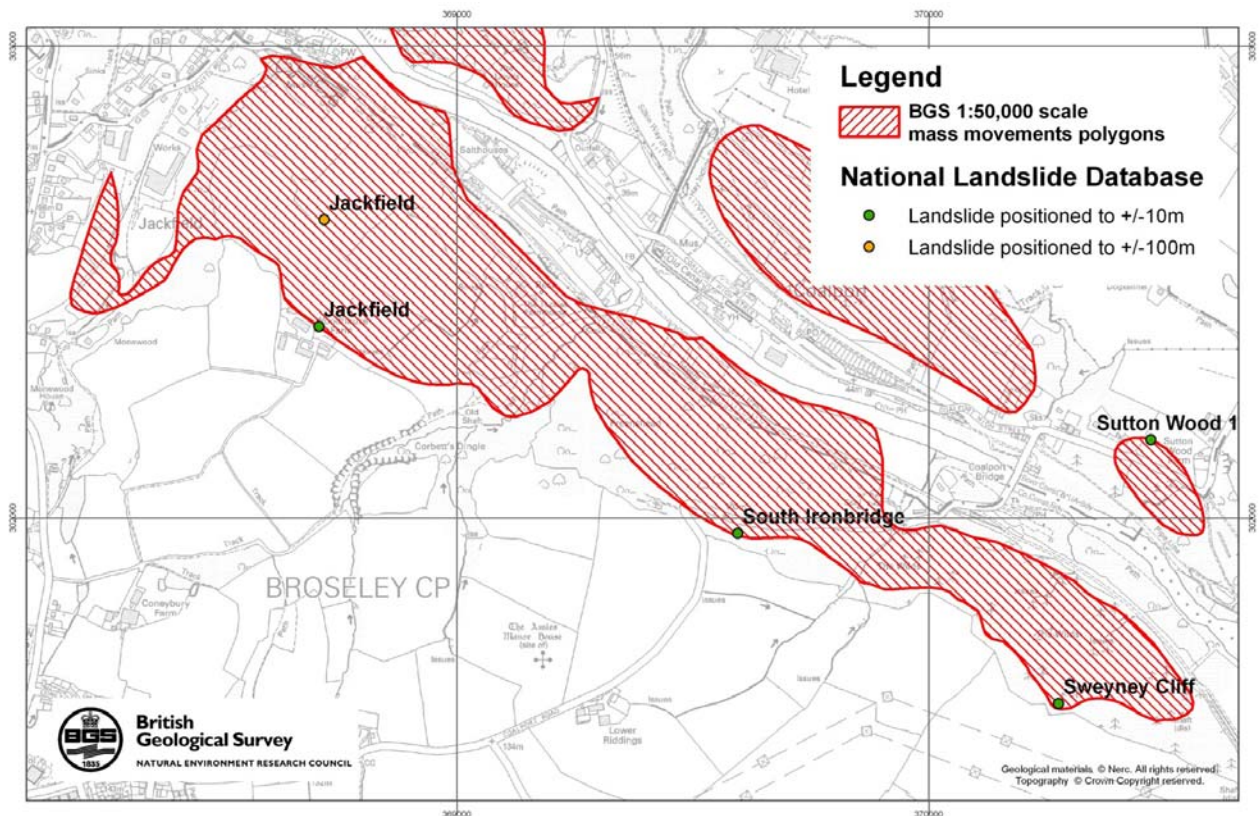
The Sutton Wood 1 landslide (NLDID 4412/1) was mapped by BGS and its extent can be seen in Figure 16. The landslide has the same characteristics as the Coalport landslide (Section 3.1.6; Hamblin and Coppack, 1995).

Figure 16 Extract from National Landslide Database including Jackfield, South Iron Bridge, Sweeney Cliff and Sutton Wood. DiGMapGB-50 mass movement polygons are also included in this map.

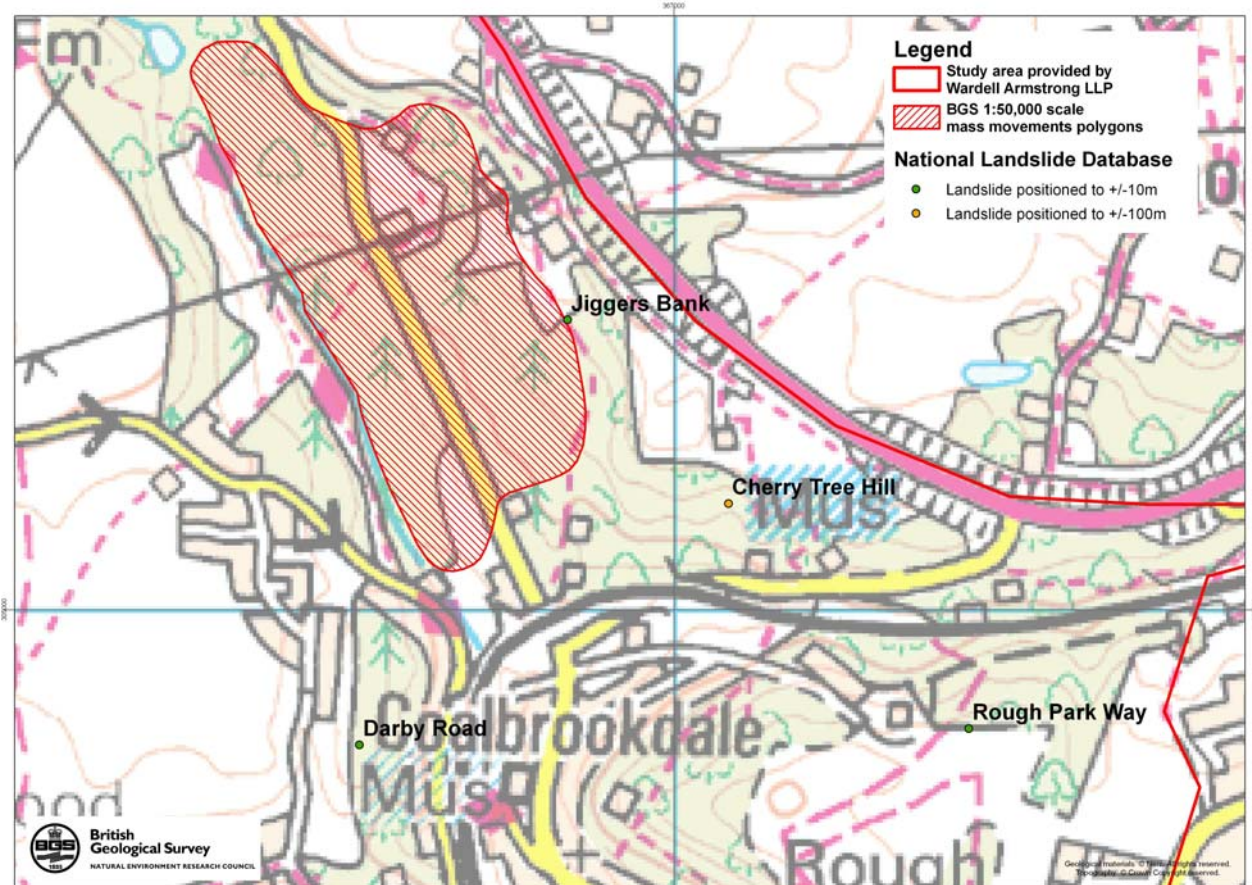
Figure 17 Extract from the National Landslide Database of Cherry Tree Hill, Rough Park Way, Darby Road and Jiggers Bank landslides. DiGMapGB-50 mass movement polygons are also included in this map.

Cherry Tree Hill landslide (**NLDID 4366/1**; Figure 17) is in an area affected by seasonal landslide movement and can vary from year to year. Although movement is imperceptible, large-scale events have been recorded and may occur. Instability is typically characterised by differential shear, tension, opening of cracks, settlement and heave. Few properties lie within the zone of ground instability in this area and of the properties inspected are subject to slight to moderate damage. Mudslides present a threat to public safety due to the very soft ground conditions. A gabion wall is located immediately above Cherry Tree Hill at the toe of the mudslide suggesting a former active section of slope.

The Rough Park Way landslide (**NLDID 4367/1**; Figure 17) is in an area affected by ongoing settlement of deep seated landslide blocks, likely to be situated on pre-existing shear surfaces. The toe of the landslide system has been developed using the benches of the blocks as terraces. The blocks are subject to settlement and creep, and the landslide processes include differential shear, tension, heave and superficial failures. The developed ground shows mainly moderate and significant damage to property. This area is likely to be subject to creep, settlement and toe heave.

Deep Seated rotational landslides have been identified along Darby Road (**NLDID 16343/1**; Figure 17). These landslides are contemporary landforms influenced by historic stream erosion and groundwater conditions. They are developed in the Wenlock Shales and failure is possibly up to 15 m below surface. The landslides comprise linear benches with gradients typically less than 5°, separated by scarp slopes with gradients of 15-25°; the benches are locally tilted backwards with ponding and soft ground accumulated to the rear side of the benches, a characteristic of deep-seated rotational and translational landslides. The landslides are probably subject to imperceptible creep, although the cumulative displacement over time can be significant. Such movement causes progressive settlement and shearing of the ground, resulting in cracking, ground heave and associated damage.

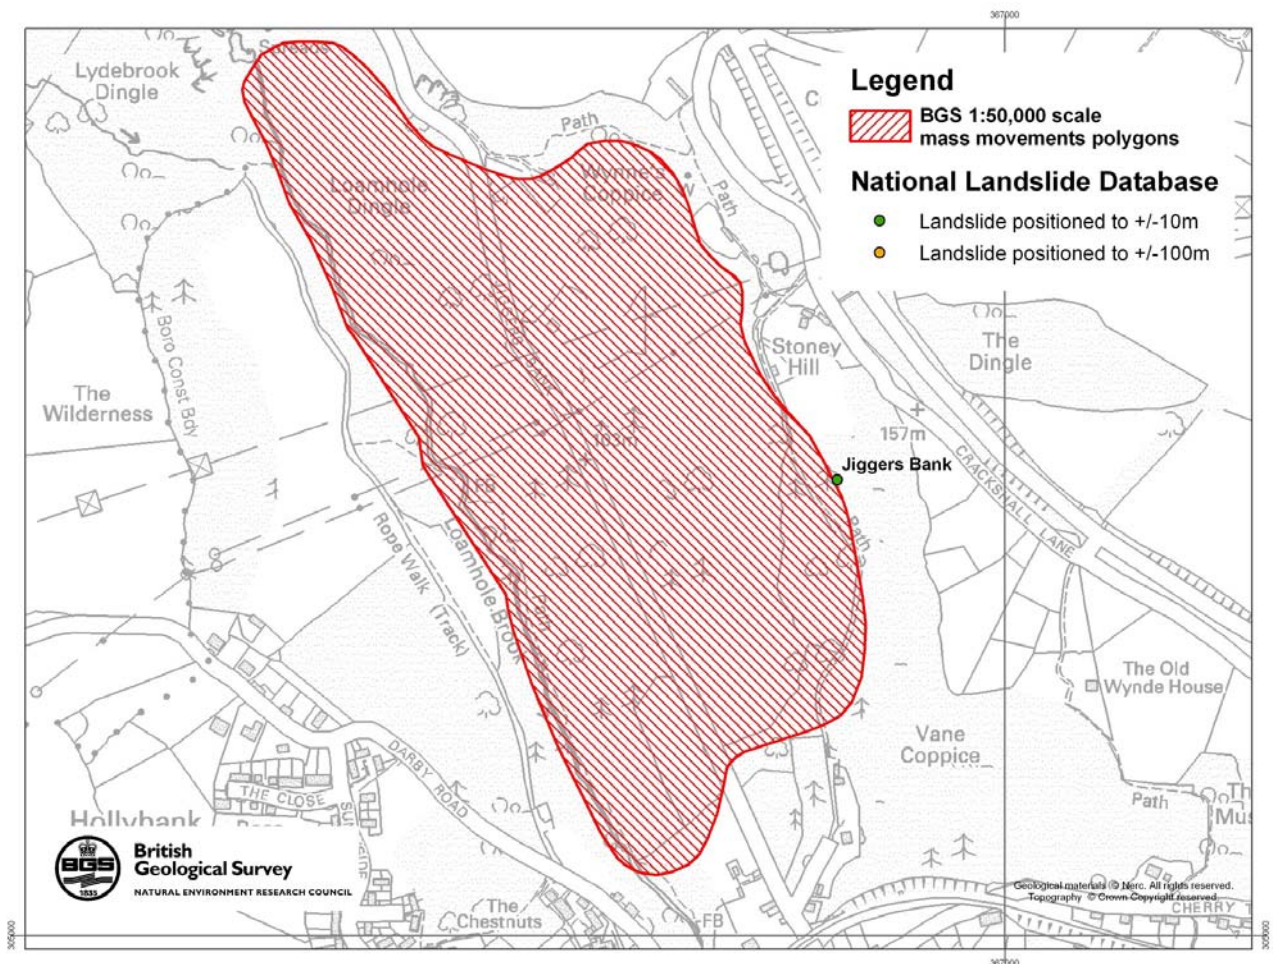
The Jiggers Bank mudslide (**NLDID 4409/1**) is located near Loamhole Dingle and was mapped by BGS and the extent of this landslide is shown in Figure 17 and Figure 18. The landslide is known to cause problems for the Coalbrookdale-Horsehay road and is a result of the Coalbrookdale Formation moving down-dip (Hamblin and Coppack, 1995; Shropshire Star, 2008b). This landslide has also been mapped by High-Point Rendel (2005b).

Two further events have been recorded as occurring in 2000 (Giles, 2008): both were small rotational landslides and the first was 15 m wide, 20 m long, 3 m deep and 900m³ in volume; the second was 22 m long, 20 m wide, 3 m deep and 1320 m³ in volume.

Figure 18 Extract from National Landslide Database for the Jiggers Bank landslide. DiGMapGB-50 mass movement polygons are also included in this map.

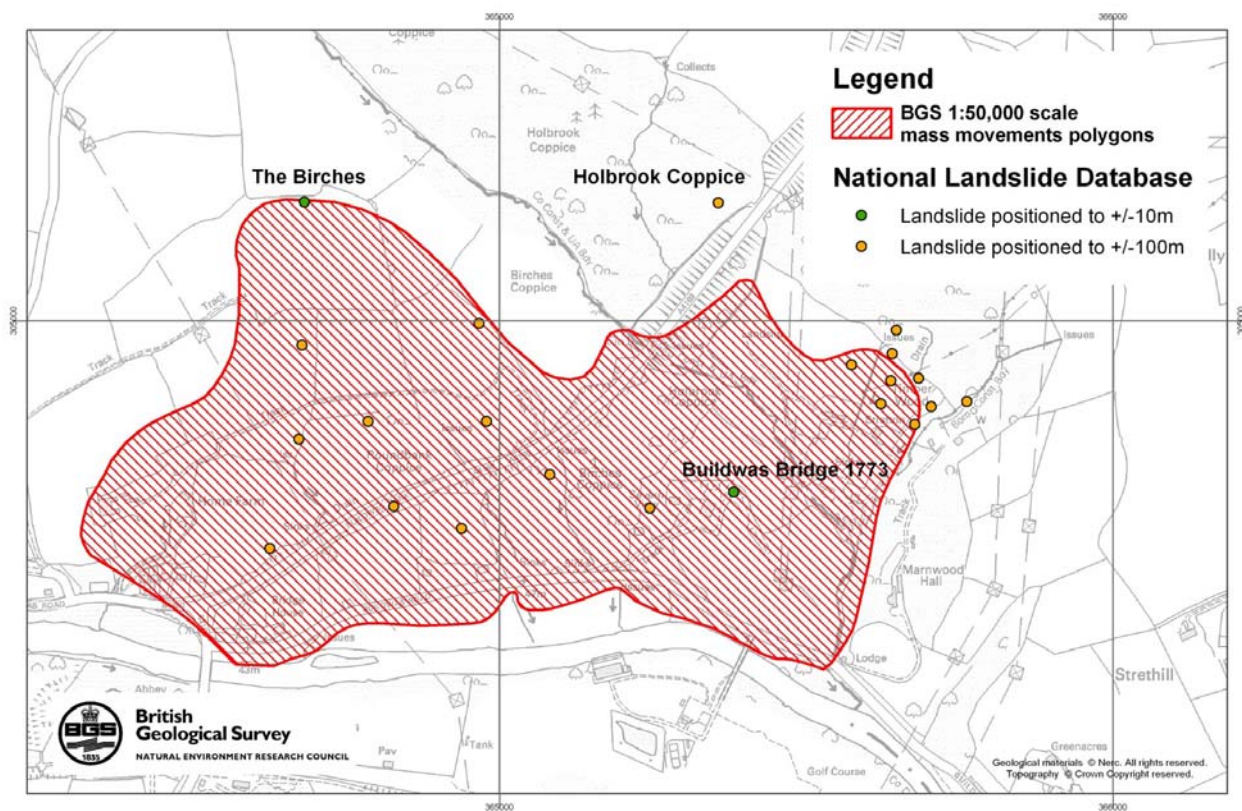
At the south-western corner of the main slip, a catastrophic slide occurred in May 1773 (**NLDID 4405/2**). All movements were completed within 15 minutes (Gostelow *et al.*, 1991). From a contemporary plan held by the Ironbridge Museum Trust, this appears to be a translational failure: the Coalbrookdale Formation dips at about 15° to the south east and a large mass moved along a bedding plane down-dip. The turnpike road was displaced, a bridge destroyed and chasms up to 11 m deep appeared behind the slip; the River Severn was blocked and cut a new course around the toe of the slip (Hamblin and Coppack, 1995). This landslide is also thought to have been controlled by two major vertical joint sets, trending approximately north-south. The

Figure 19 Extract from National Landslide Database for the Birches landslide. The points on this map are for the different National Landslide Database Surveys for this landslide which includes the Buildwas Bridge landslide of 1773 and Holbrook Coppice landslide. DiGMapGB-50 mass movement polygons are also included in this map.

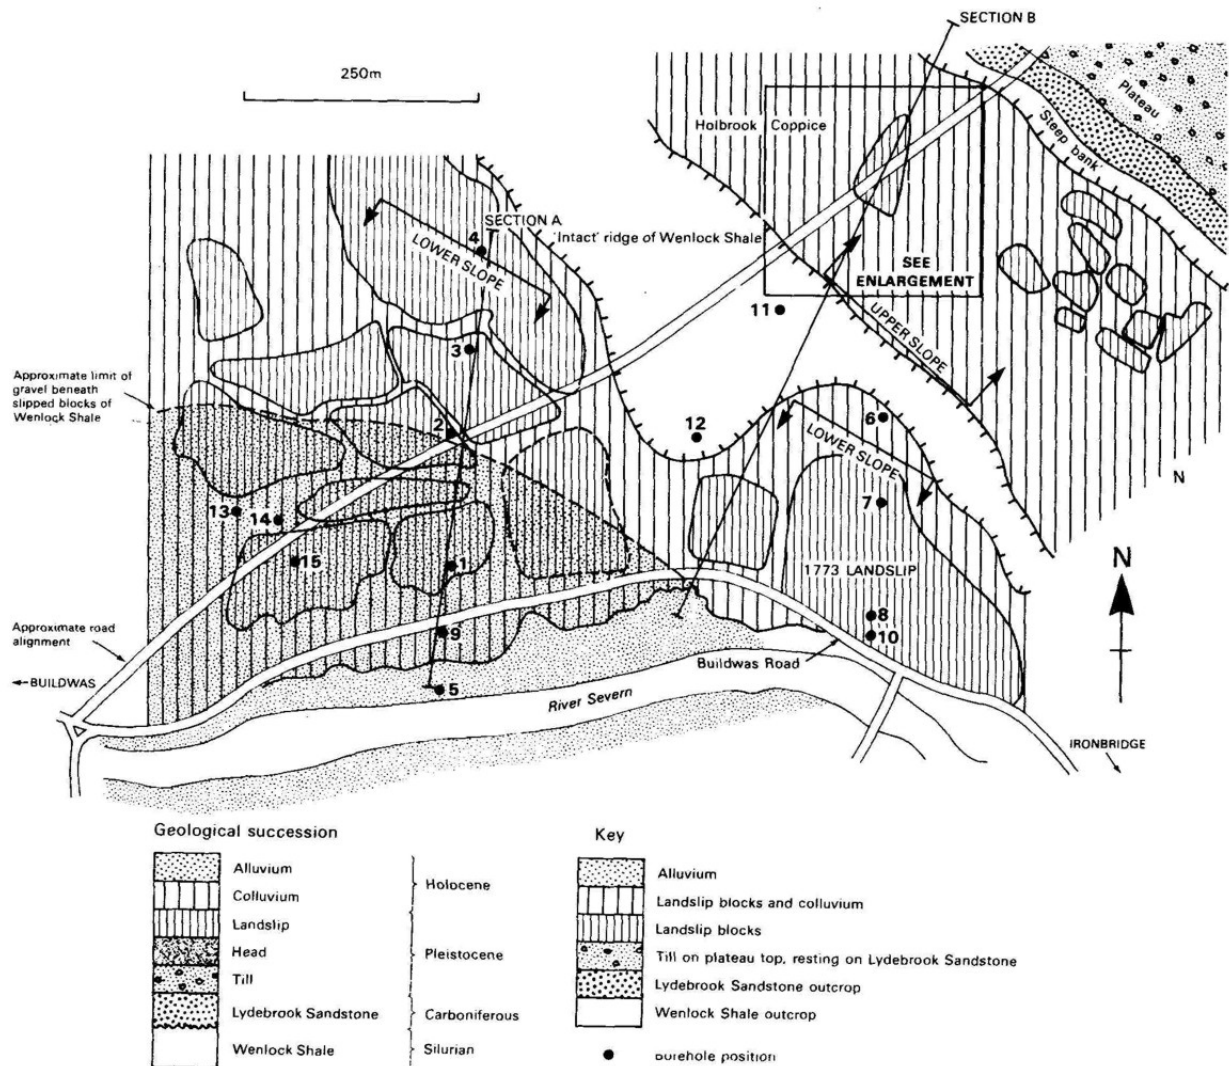
Gostelow *et al.* (1991) also mapped a series of rotated blocks within the lower and upper slopes of this landslide from aerial photographs (NLDID 4405/3-21), including Holbrook Coppice landslide (NLDID 16431/1). See Figure 20. Gostelow *et al.* state that it is likely that these landslides are translational types and similar to the Buildwas Bridge 1773 landslide. Gostelow and Hamblin (1979a) also describe bands of bentonite up to 45 cm thick associated with landsliding and state that the area of slip immediately north of Buildwas Bridge was still active as the bridge itself and the buildings nearby showed signs of movement. This area probably represents the re-activation of the western end of the Late Glacial solifluction (mudflow) material.

Figure 20 Extent of landslide blocks mapped in the Buildwas area (taken from Gostelow *et al.*, 1991).
